Linden Hall CAE Photo Album

October 6, 2011

Electrical Service / Masonry Progress /
Attic HVAC

By Chambers & Associates

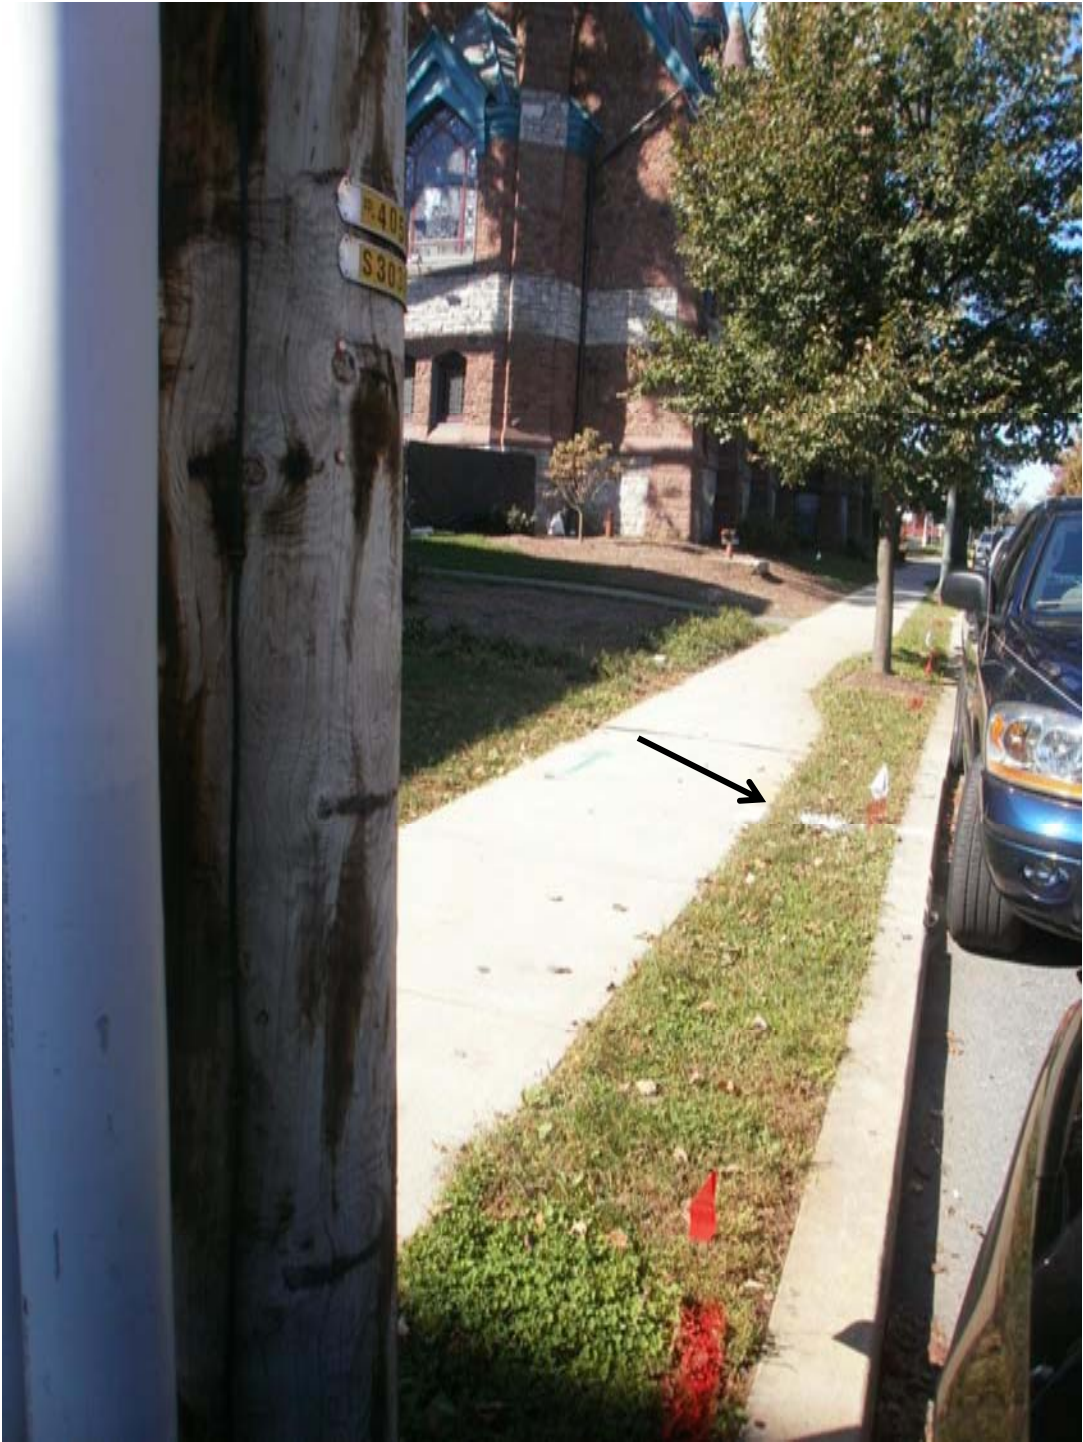
**Location of new
electrical service
pole**

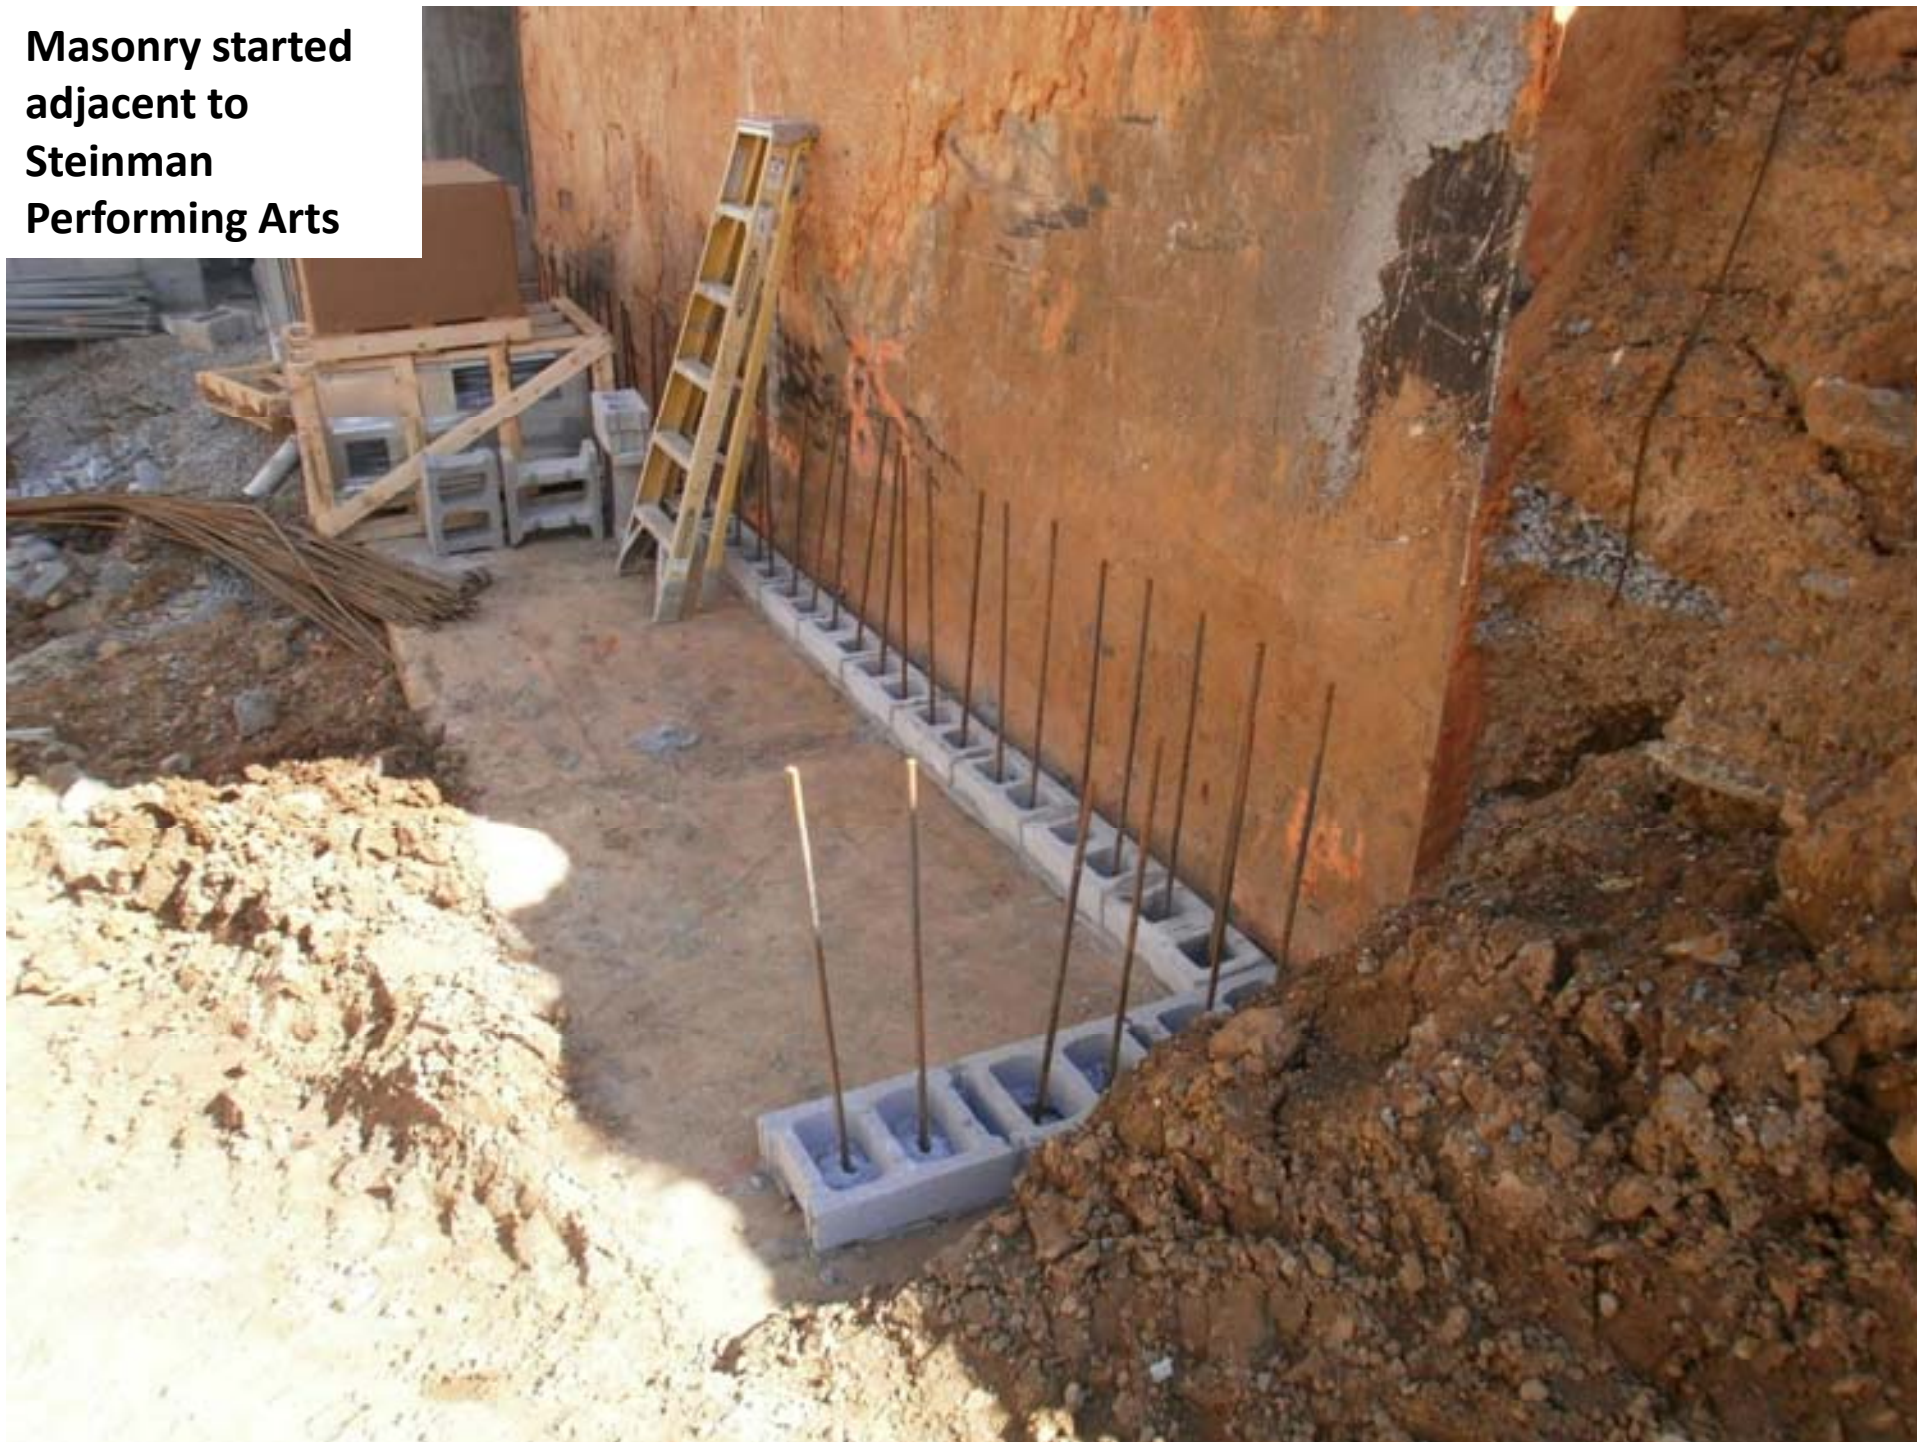
**Masonry started
adjacent to
Steinman
Performing Arts**

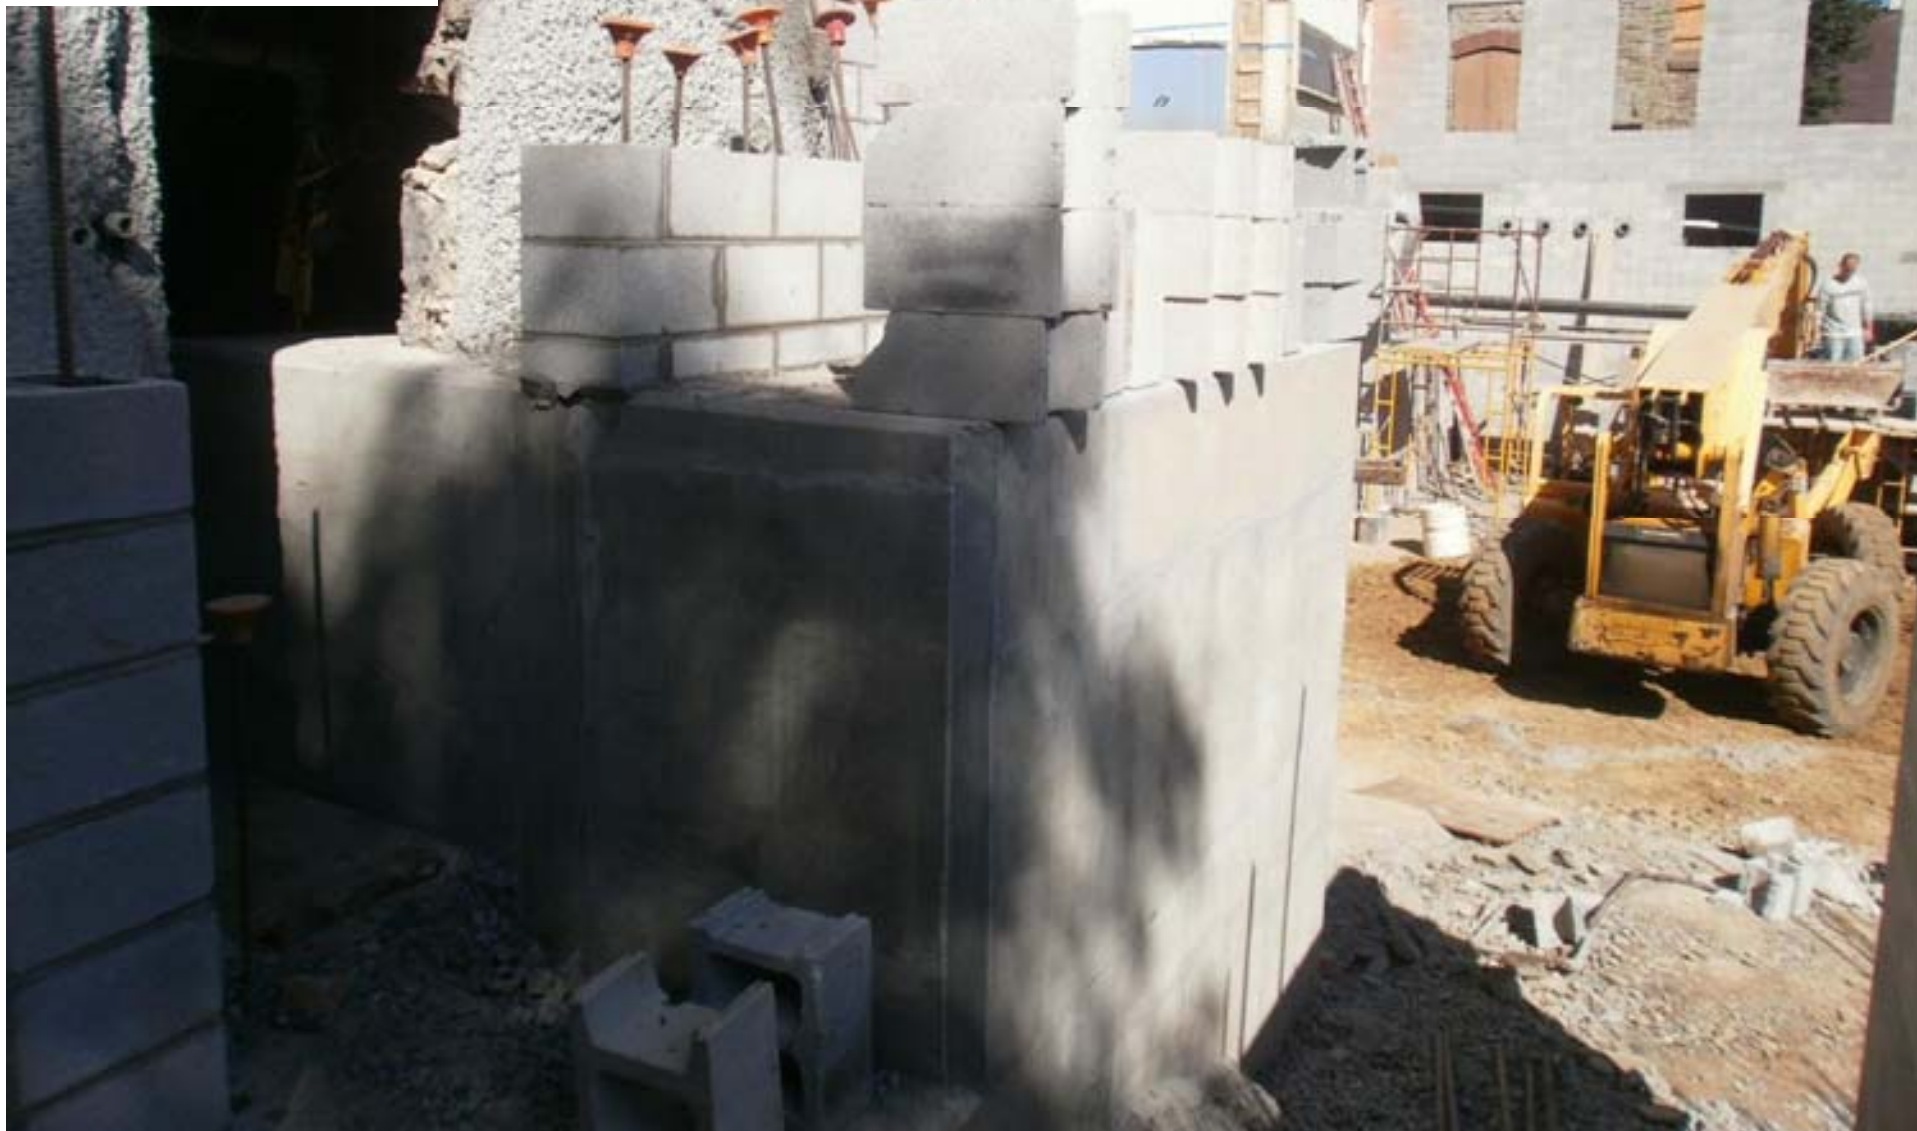
**Looking north at
the foundation
poured around the
rock in the existing
foundation**

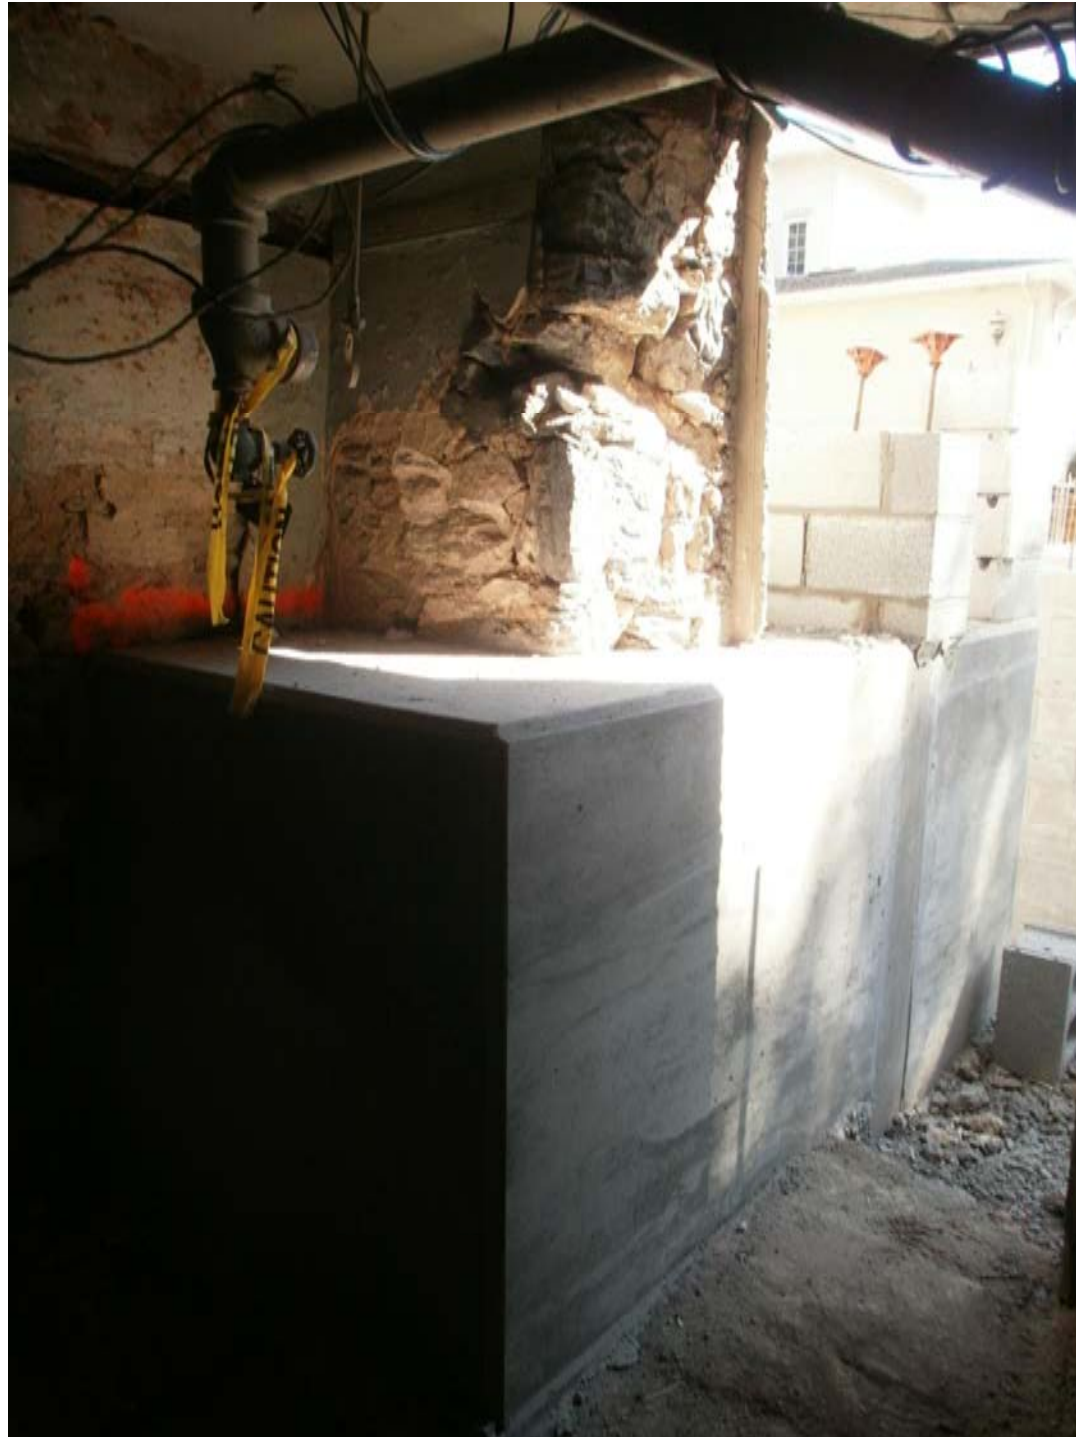
**Looking east from
the basement at
the rock in the
foundation
encased in
concrete**

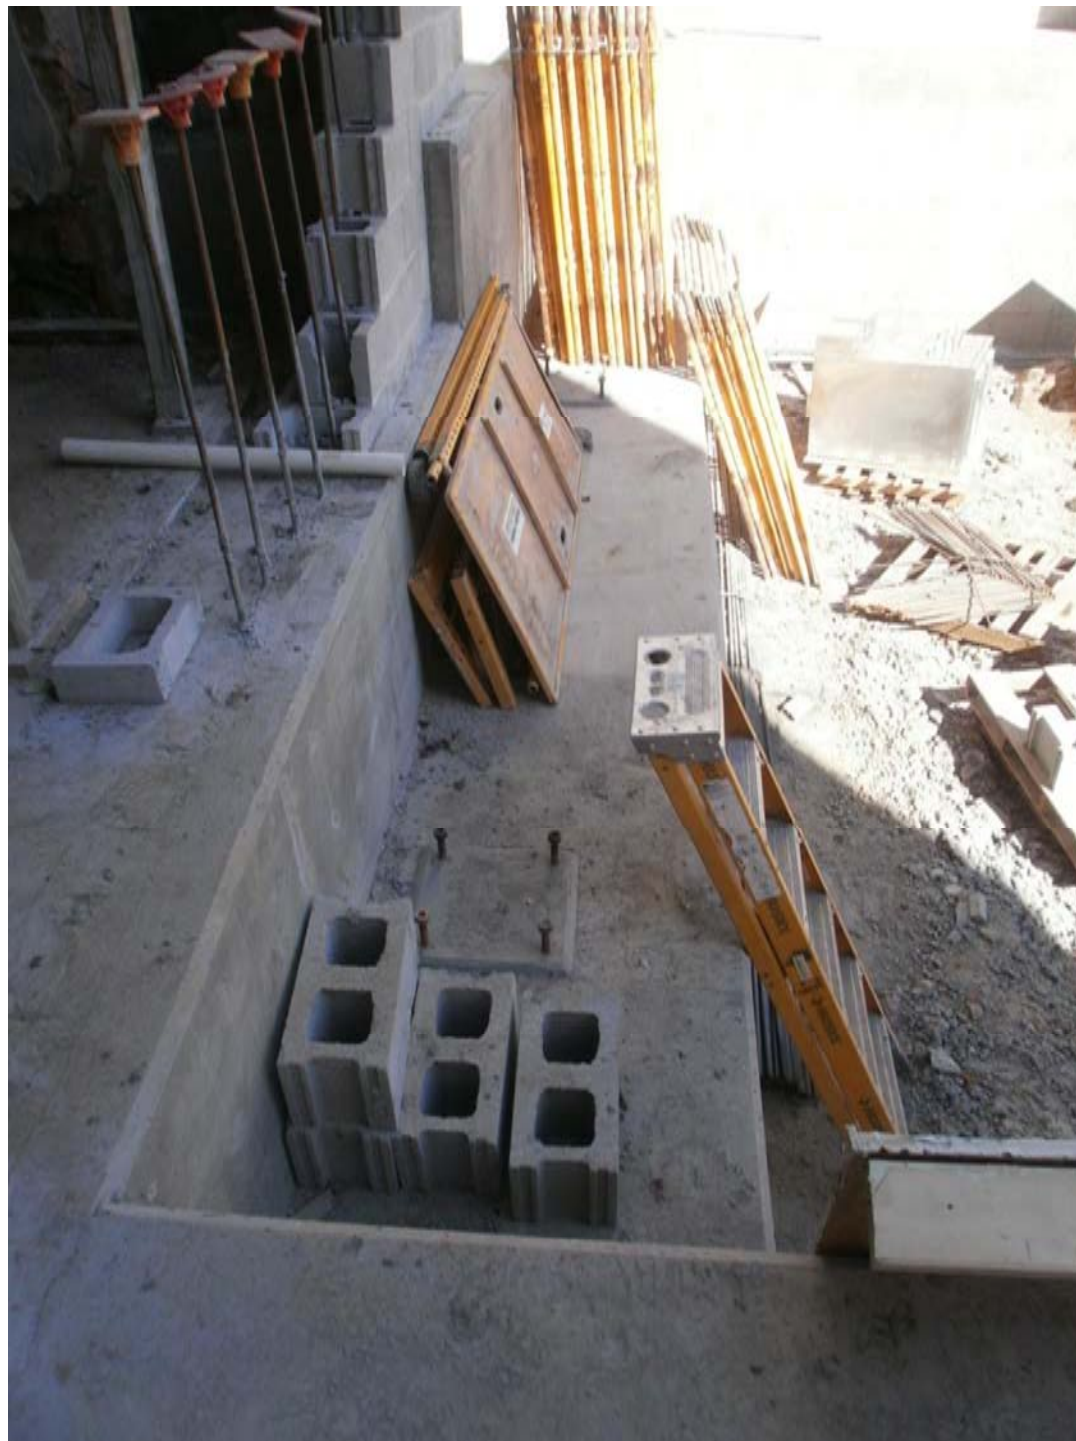
**Looking north
from under the
1769 porch at
column footings
ready for steel**

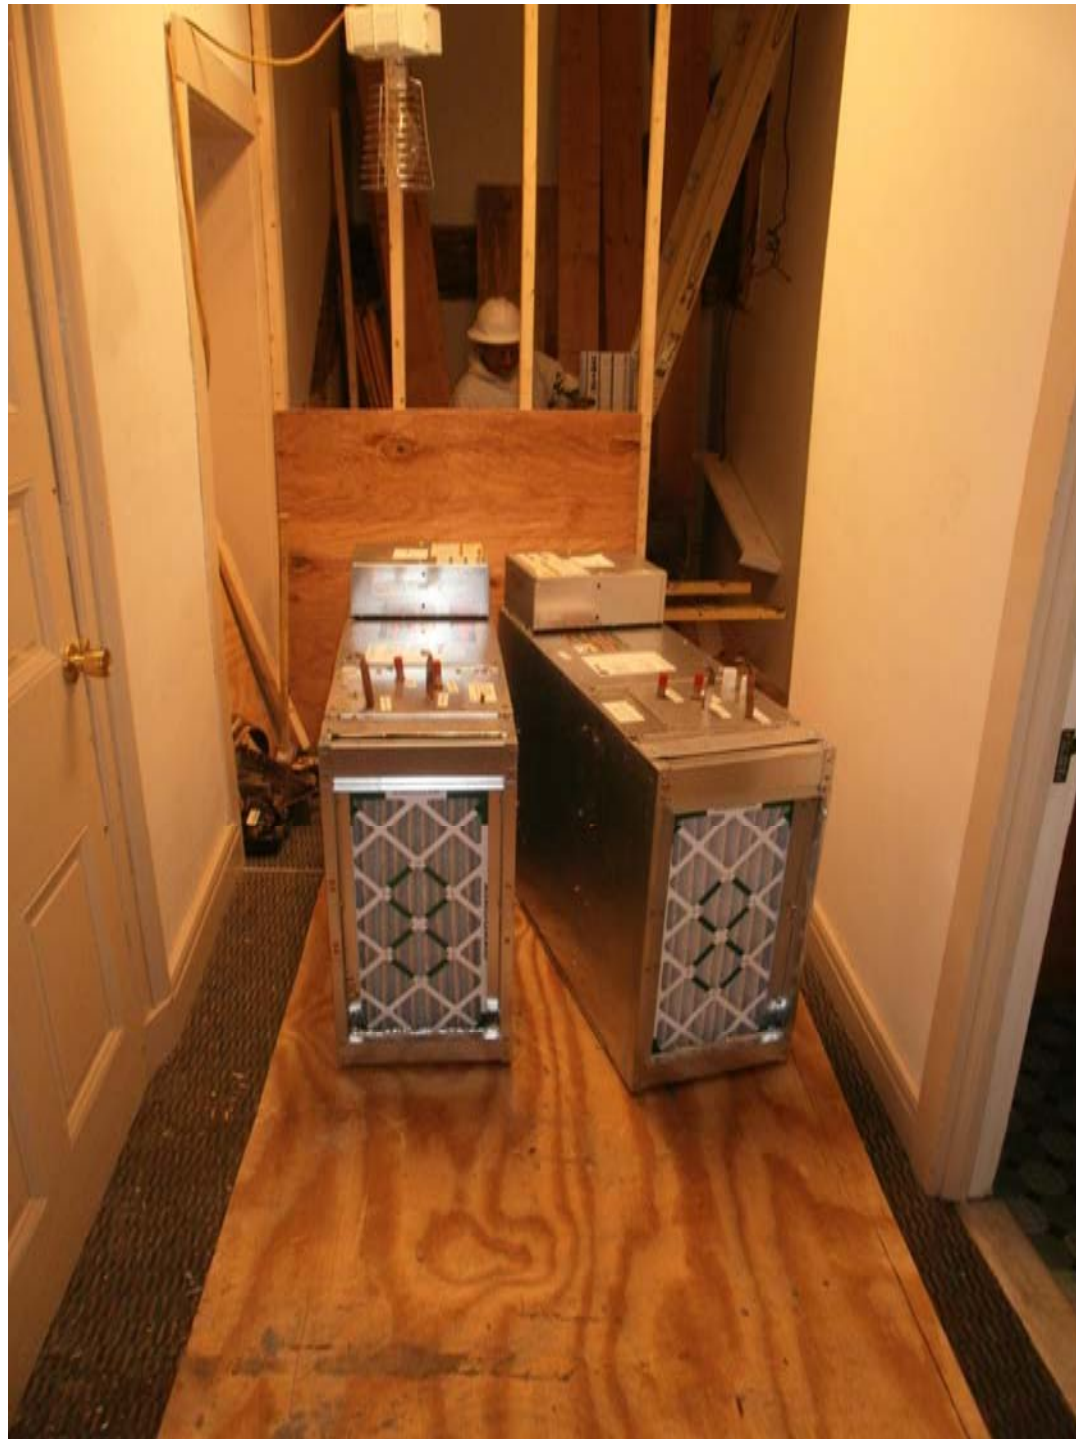
**Attic furnaces
being moved
upstairs**
